Service Bulletin 4812 712 40387

TITLE: LID does not stay in open position on HR (High Range)models.

SUBJECT: In some circumstances can it happen, that the door lid does not stay in open position.

Top frame Boston adjustment – on Top Loader HR (High Range) “Lid doesn't stay in open position”

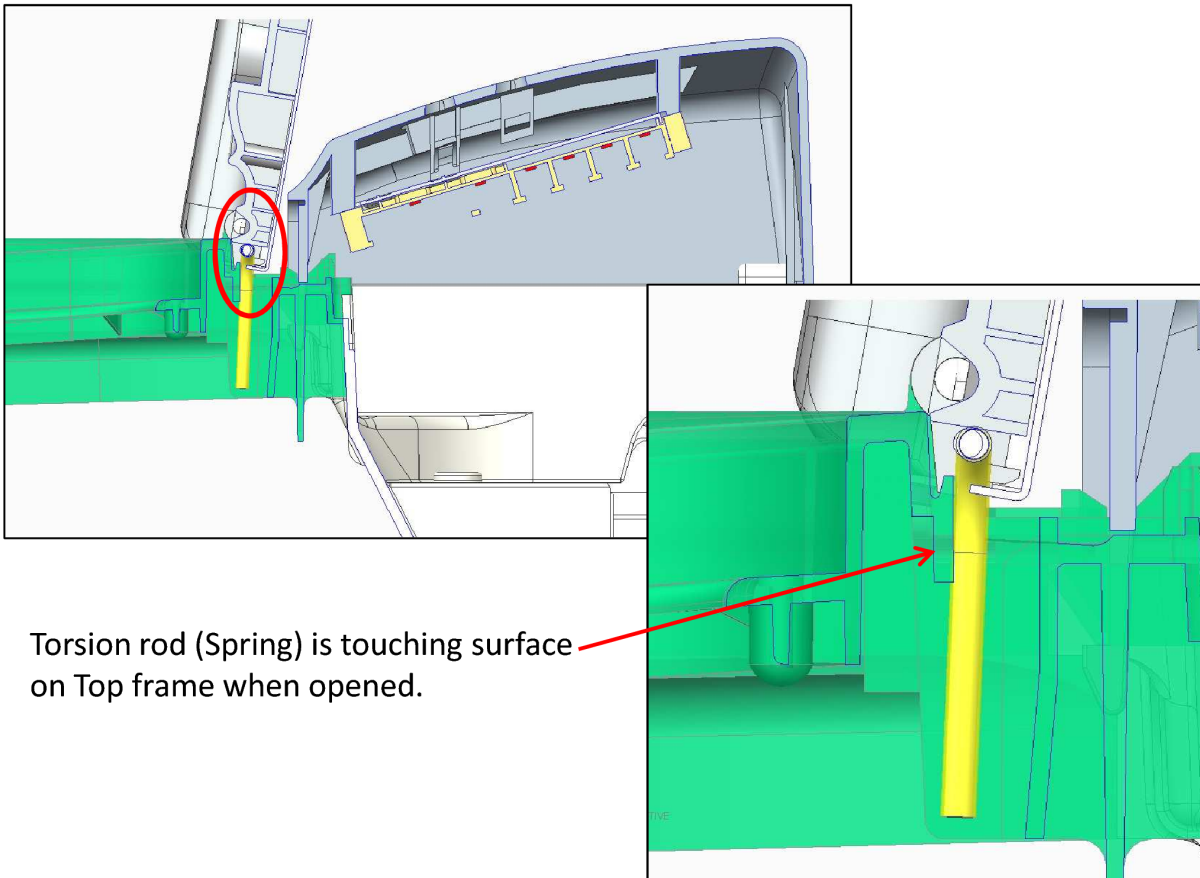
Root cause: Torsion rod (Spring) is touching surface on Top frame when opened, which causes to don't stay in open position!

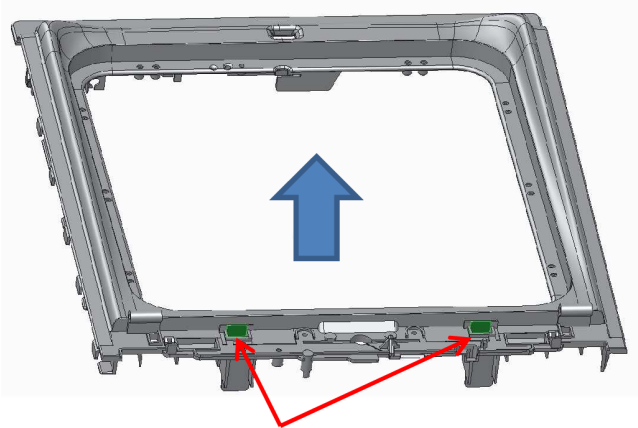
Torsion rod (Spring) is touching surface
on Top frame when opened.

It is required to adjust (cut &/or grind) away material on pointed surfaces towards to the front (not rear!).
